MCKENZIE RIVER SUBBASIN ASSESSMENT

Summary Report 2000

DOE/BP-23129-2

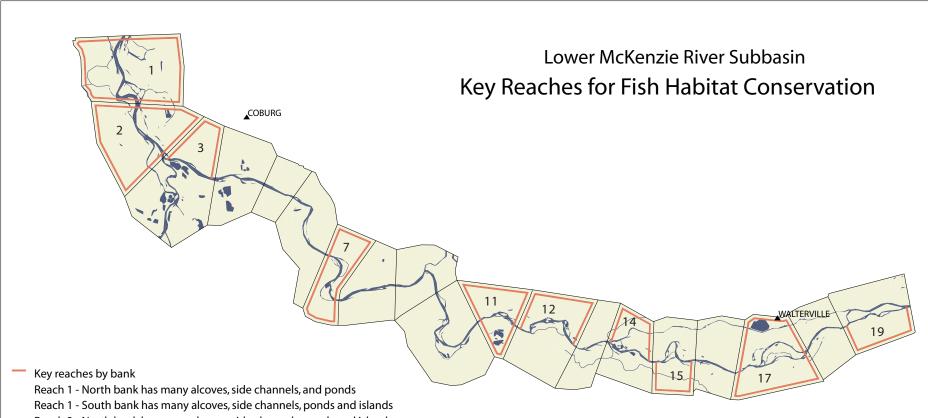
Lower McKenzie River Subbasin Key Reaches for Wildlife Habitat Conservation

- Reach 2 North bank has many alcoves, side channels, ponds and islands
- Reach 2 South bank has alcoves, side channels, ponds and islands
- Reach 3 North bank has islands, alcoves, and side channels
- Reach 7 North bank has meander area
- Reach 7 South bank has large area in side channel, island, and alcoves
- Reach 11 North bank has meander area
- Reach 11 South bank is flood-prone plain with side channels and islands
- Reach 12 North bank has many side channels and islands
- Reach 14 North bank has old gravel pit complex now connected to main channel
- Reach 15 South bank has tight bend in river creating extensive meandering
- Reach 17 North bank has many alcoves, side channels, ponds
- Reach 17 South bank has side channels and ponds
- Reach 19 South bank has large islands (Kaldor and Rodman) and side channels

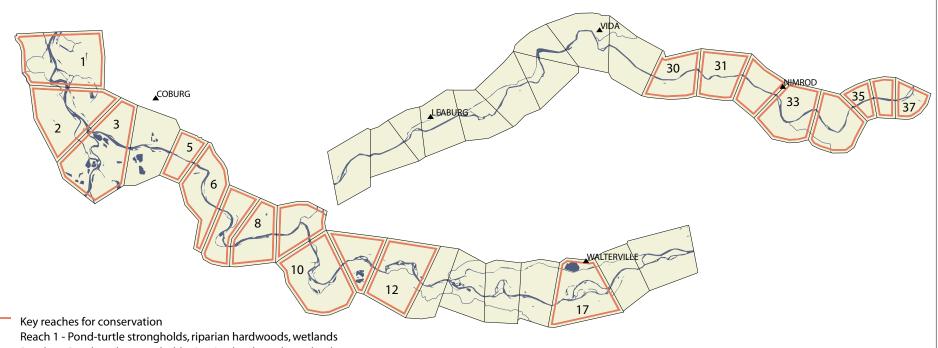
Figure 3

- Reach 2 Pond-turtle strongholds, riparian hardwoods, wetlands
- Reach 3 Pond-turtle strongholds
- Reach 5 Riparian hardwoods
- Reach 6 Riparian hardwoods, oak woodlands
- Reach 7 Riparian hardwoods, oak woodlands
- Reach 8 Riparian hardwoods, oak woodlands
- Reach 9 Oak savannahs and woodlands
- Reach 10 Pond-turtle strongholds
- Reach 11 Pond-turtle strongholds, oak woodlands, wetlands
- Reach 12 Pond-turtle strongholds, wetlands
- Reach 17 Wetlands
- Reaches 30-37 Limnetic features (older conifers near river for bald eagles)

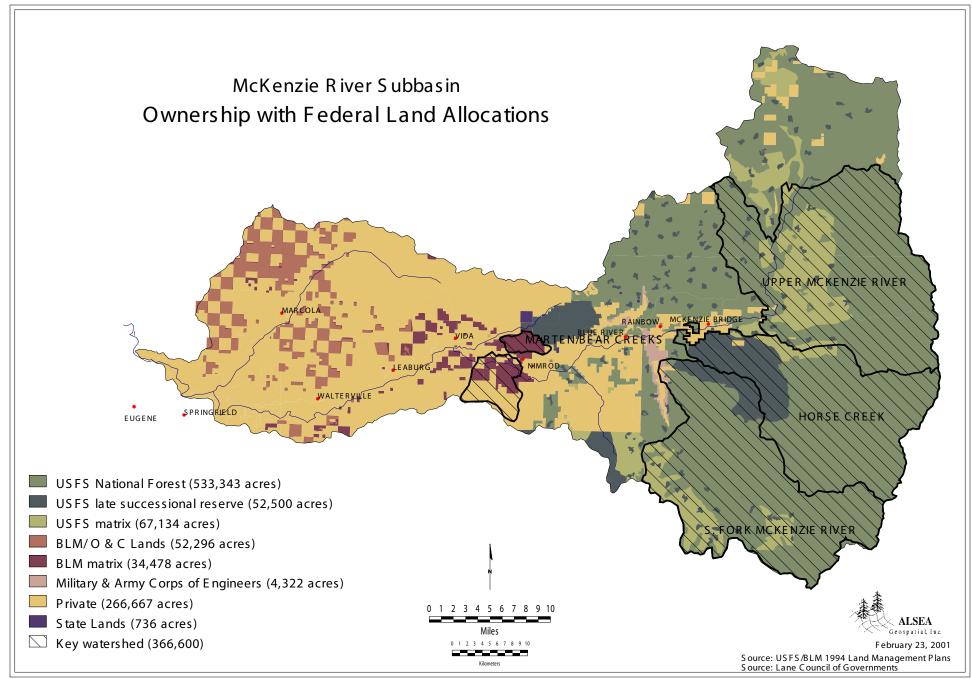
Figure 7

In the upper subbasin, large contiguous blocks of federal land are managed by the USDA Forest Service. Below Blue River, federal and private forest lands are mixed in a checkerboard ownership pattern, with federal lands managed by the Bureau of Land Management (BLM), and the private forest lands owned and managed by forest industry companies. Almost all of the floodplain is private land (Figure 7).

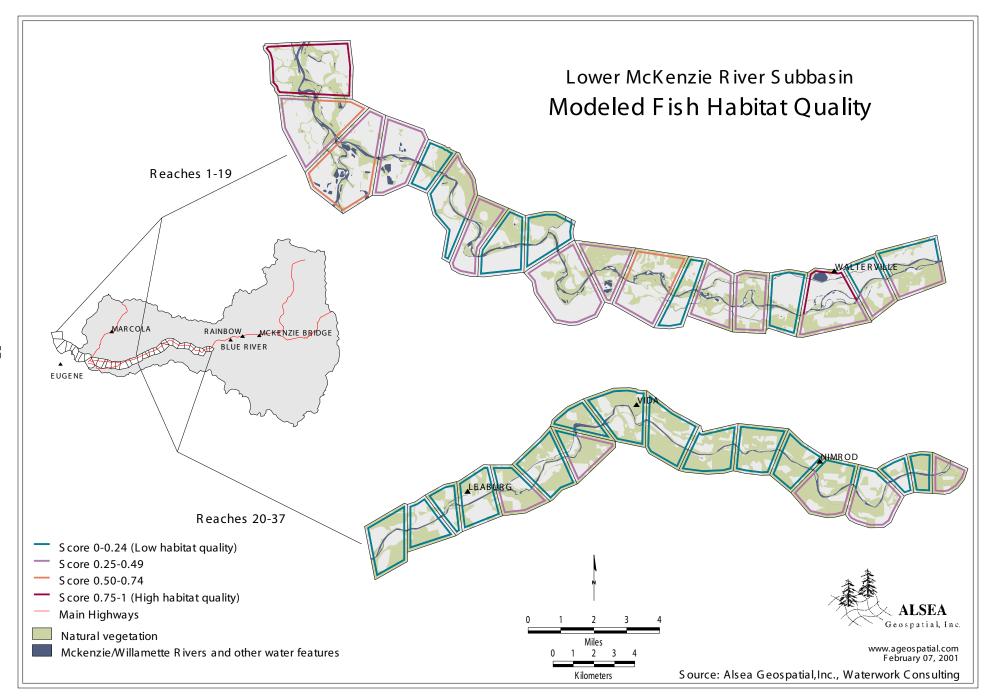
Figure 12

In this section we present a method for scoring fish habitat quality within reaches of the McKenzie River. We scored habitat quality for 1944 and 2000 conditions, using information obtained from aerial photographs. In addition, we had limited field survey information for 2000. The objective was to identify areas or reaches (by north or south side) that currently have high-quality fish habitat or those that had high quality in 1944. Scoring fish habitat quality can help to identify areas that are high priorities for conservation or restoration.

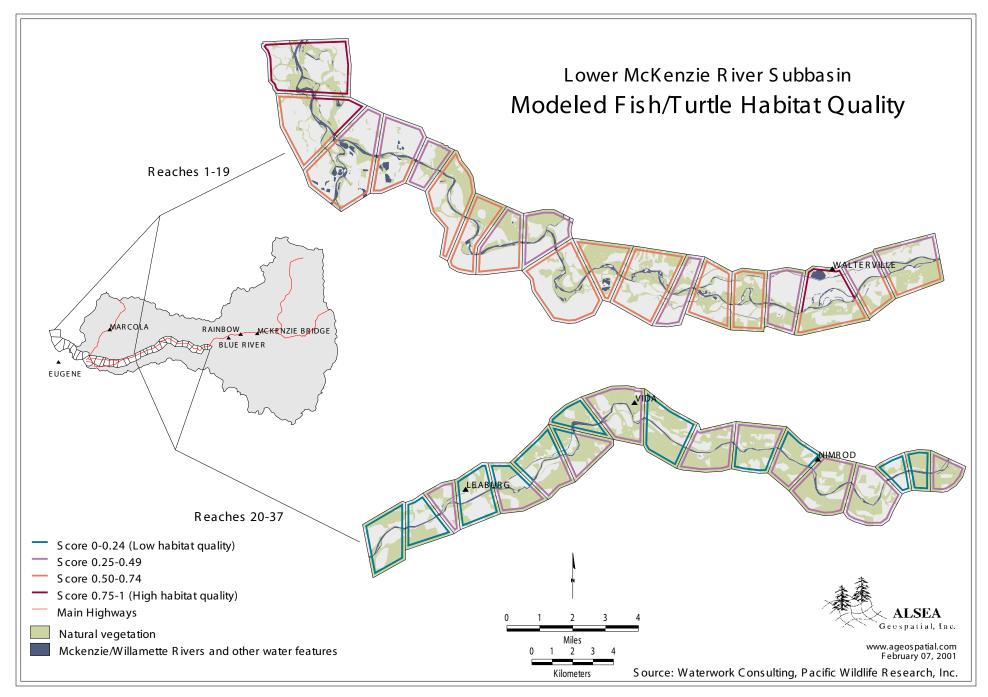
Figure 13

We took the pond turtle habitat suitability scores produced from the pond turtle model, standardized their values, and combined them with the juvenile chinook habitat scores. The two scores were summed with equal weighting assigned for turtle and fish scores. This composite chinook/turtle habitat score was highest downstream from Deerhorn Bridge at Reach 20. Reaches 1 and 2, Reaches 10 to 12, and Reaches 17 to 19 had some of the highest scores in the lower half of the study area (Figure 13).
